DEVELOPING A MANUAL FOR THE IDENTIFICATION OF STRUCTURAL PATHOLOGIES FOR THE REPAIR OF MASONRY SOCIAL HOUSING IN METROPOLITAN LIMA DIGITE EL NOMBRE EXACTO DEL TÍTULO PROFESIONAL.

Universidad Privada del Norte

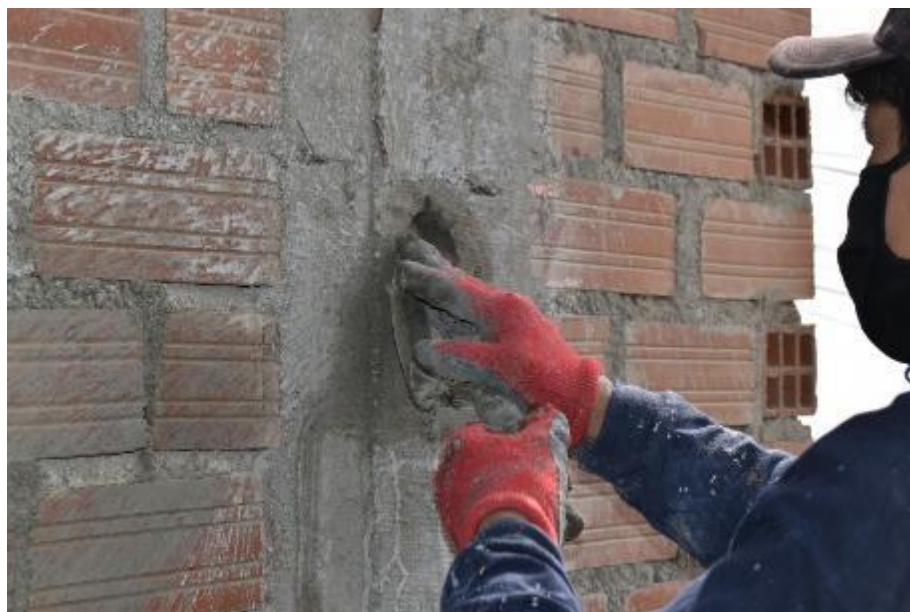
Figure 9. Repair process of the extracted cylindrical core.

The materials used were cementitious mortar of high strength or greater than the design of the house, together with a primer for proper adhesion.
