IMPLEMENTATION AND TREATMENT OF CEMENT GROUT MIXTURE FOR UNDERGROUND CAVITIES

ABSTRACT: Permeation grouting is a potential method of improving the technical features of sandy soils. This method injects grout into the soil for uninterrupted the soil structure. This analysis attempts to compare infiltration injection with cement and lime grouts. A total of eight sinkholes were found in a suburban residence area. This concludes the overload for under karst caves which is the primary reason of the subsidence progression. Padding the karst cavities with cement grouts were selected as a remedy for the cavities problem. Continuous monitoring of elevation at several selected points in critical locations prior to grouting operations to fill cavities in karst terrain should be calculated and taken as a warning of significant movement or subsidence. It was considered to be an essential tool for detecting small movements and changes that can

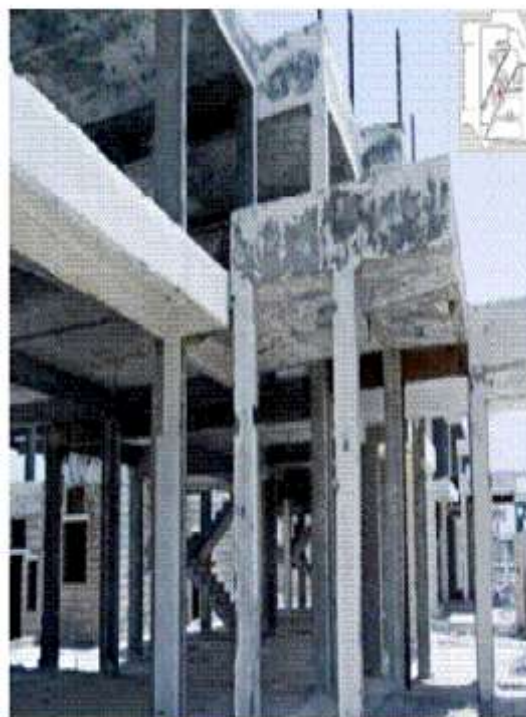
Figure.1: Dilapidation Photo

A building case is a completed document of land and buildings at a particular period. The investigation began by explaining the situation of available designs, identifying problems, and creating an overview of existing defects before implementing treatment methods. Numerous photographs were considered, along with overviews of place, descriptions, and close-ups for few designs and installations. For each photo, detailed localization, the date the photo was taken, photo number, and locations on the main map are noted.

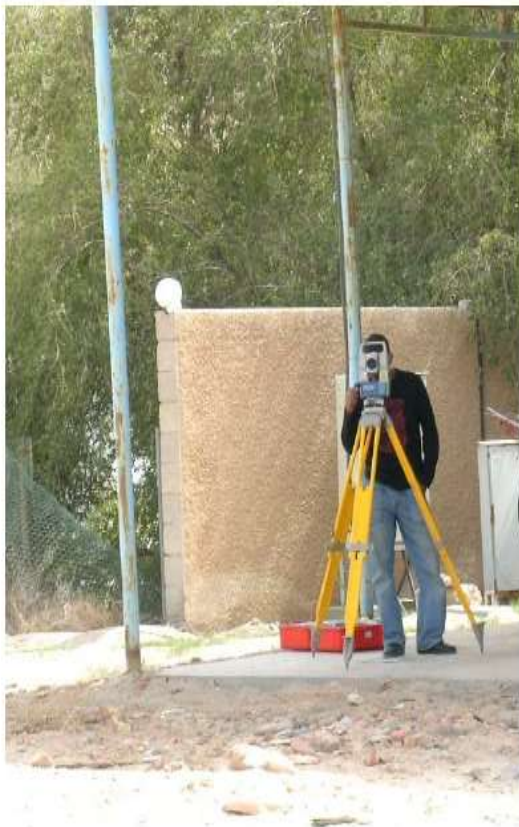
Figure.2: Recording Readings

underpasses, gardens, courtyards, canals, culverts and fountains, and services. Associated designs such as water pipes, sewers and utility poles (both above and below ground). These are considered "finished" drawings. Topographic surveys were primarily focused on regularly recording elevation in and around the treatment area. In addition to the points selected for each dwelling unit, elevation points are arranged on the down plane in a grid pattern at intervals of 50 m. The measured values were calculated and noted by utilizing stations of survey device. All warnings of unwanted ground movement were monitored and subjected onto maps and tables.

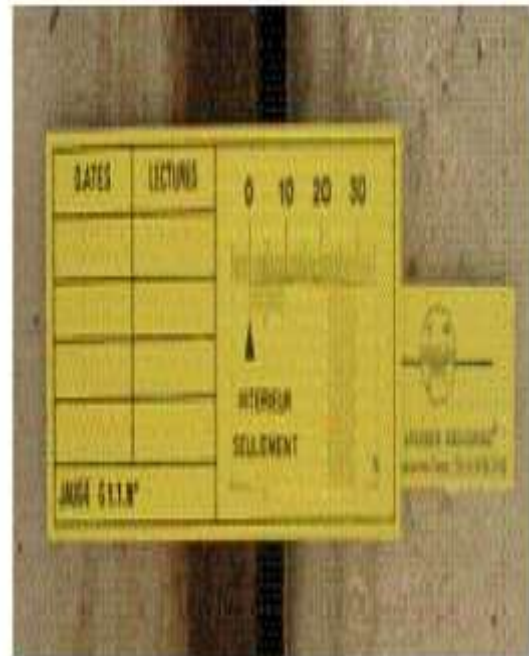
Figure.3: Crack-Meter

The cracks gauge with an accuracy of 0.001 mm was utilized to note the movement of the choose element. It is installed on-site primarily in designs, near sinkholes, and others places where movement was doubted. Numerous crack gauges were installed in the pillars, ceilings and structural attachments for

above or below plane surfaces. The gauge is installed in asphalt near progressive sinkhole. Each of them is detected by a label that contains the required data regarding the position and construction in which it will be installed.

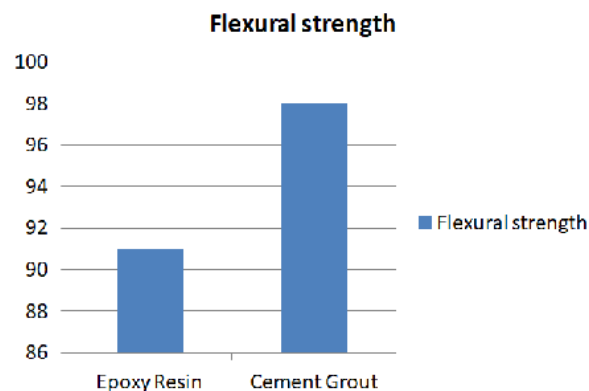
Fig.4 Flexural Strength Comparison Graph

Fig.4 shows Flexural strength comparison graph between Epoxy Resin and Cement Grout. The Cement Grout shows high Flexural strength.

Parameters	Epoxy Resin	Cement Grout
Flexural strength (%)	91	98
Tensile Strength (%)	89	92
Cracks (%)	92	85

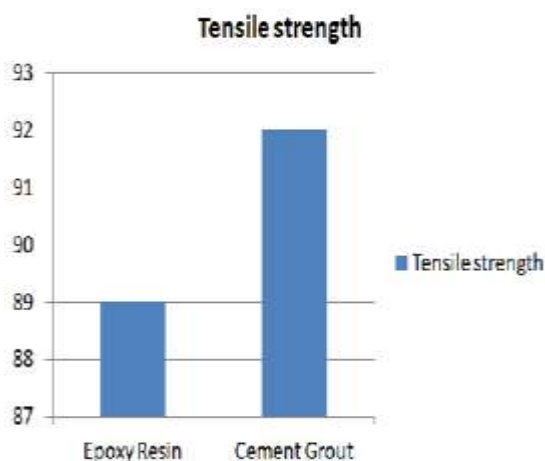
Fig.5 Tensile Strength Comparison Graph

Fig.5 shows comparison graph of Tensile Strength for Epoxy Resin and Cement Grout. Where as Cement Grout Shows higher tensile strength.

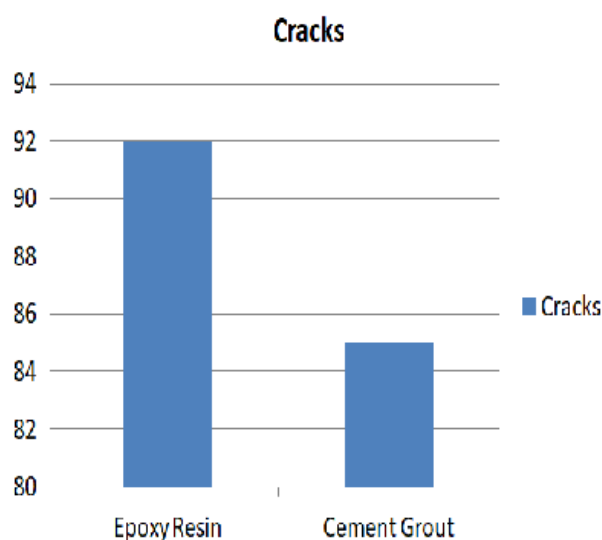
Fig.6 Cracks Comparison Graph

In this comparison graph, the cracks percentage in Cement Grout is decreased when compared with Epoxy Resin in fig.6.
