Repair Shear Bond Strength Of Aged Resin Composite After Different Surface Treatments And Its Mode Of Failures: An In Vitro Study.

Keywords: Composite, Repair, Mode of failures, Shear bond strength, Surface treatment

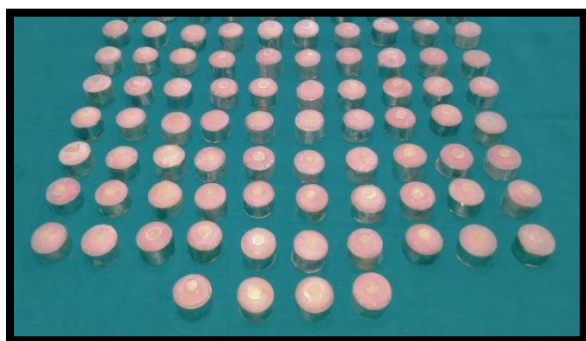
Fig 1: Samples

Seventy-two specimens of composite were made by using cylindrical stainless steel mould of diameter 240 mm and height of 140 mm for the purpose of this in vitro study(**Fig 1**). Acrylic resin was poured into stainless steel cylinder moulds that had been created for the specimens. On the cylindrical acrylic blocks, a hole measuring 80 millimeter in diameter and 40 millimeter in height was made. Holes were filled with nanohybrid composite (Ivoclar Vivadent, Tetric N-Ceram) of shade A3 to simulate existing restoration with incremental layering technique each of thickness two millimeter layer of composite was light cured for 40 sec by a L.E.D curing light (Woodpecker, China) for 40 seconds with wavelength of 420 nm- 480 nm and it was fully perpendicular to the mold.

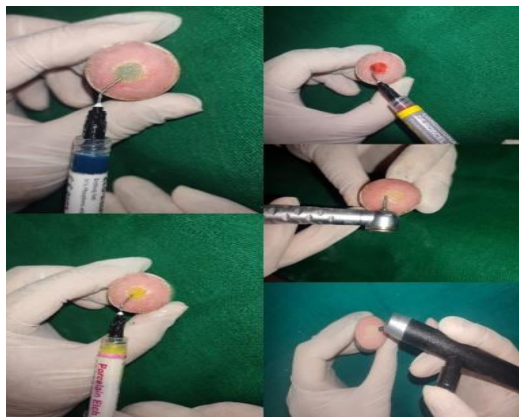
Fig 2: Surface treatment

Afterward, specimens were randomly separated into 6 groups of 12 samples each, according to the surface treatment method. (**Fig. 2**)

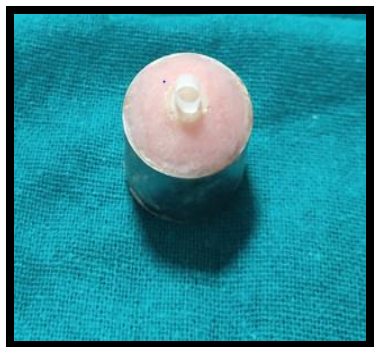
Fig 3: Repair procedure

After different type of surface treatments, a new seventh- generation bonding agent (Beautibond, Shofu, Japan) was sprayed to the surface of aged composite, dried with compressed air, and light-cured for 5 seconds. Next, a piece of plastic hollow straw measuring 5 mm in diameter and 4 mm in height was placed in the centre of the flattened area of aged composite for each sample(**Fig. 3**). Then nanohybrid composite resin of A1 shades (Ivoclar Vivadent, Tetric N-Ceram), which was differed from original composite block was placed in order to differentiate between existing restoration and repaired restoration composite block with dimensions of 5 mm in diameter and 4 mm in height was constructed in 2 mm increments in thickness. An LED light curing device was used to light cure a mylar strip over the last increment for 20 seconds (Woodpecker L.E.D curing light). The straw was broken off and taken away. Then samples was submitted for shear bond test in a universal testing machine (Shimadzu, Japan) with a crosshead speed of 0.5 millimetres per minute until fracture(**Fig. 4**).

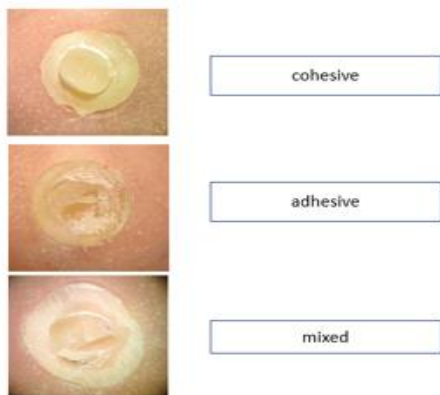
Fig 5: Mode of failures

After shear bond strength test, the samples were evaluated under a stereomicroscope (Labomed, Cz4 model, USA) at x40 (**Fig. 5**) to check the modes of failures as

1. Adhesive: Failure at the interface
2. Cohesive: Fracture of base or repair composite
3. Mixed: Failure at the interface and the repair composite are included.

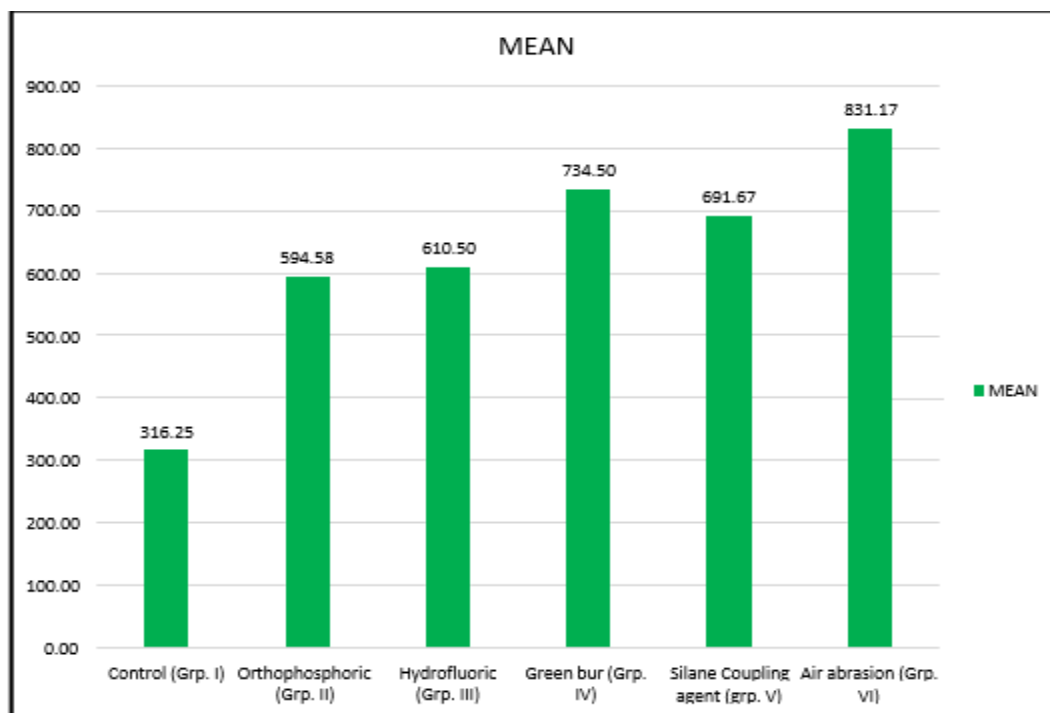
Fig 6 The mean shear bond strength comparison values of all the groups

The mean and standard deviation values of Shear Bond Strength (N) of different groups represented in Table 1. The highest shear bond strength was found in group VI (Air abrasion) and the lowest in group I (Control). One-way ANOVA for multiple group comparisons and Tukey HSD Test Post Treatment for differences among mean. As shown in table 2, amongst all the groups showed significant difference ($p < 0.001$) except comparison between Orthophosphoric acid (Gp II) and Hydrofluoric acid (Gp III) showed non-significant values ($p > 0.001$).

Fig 6 shows the mean shear bond strength comparison values of all the groups

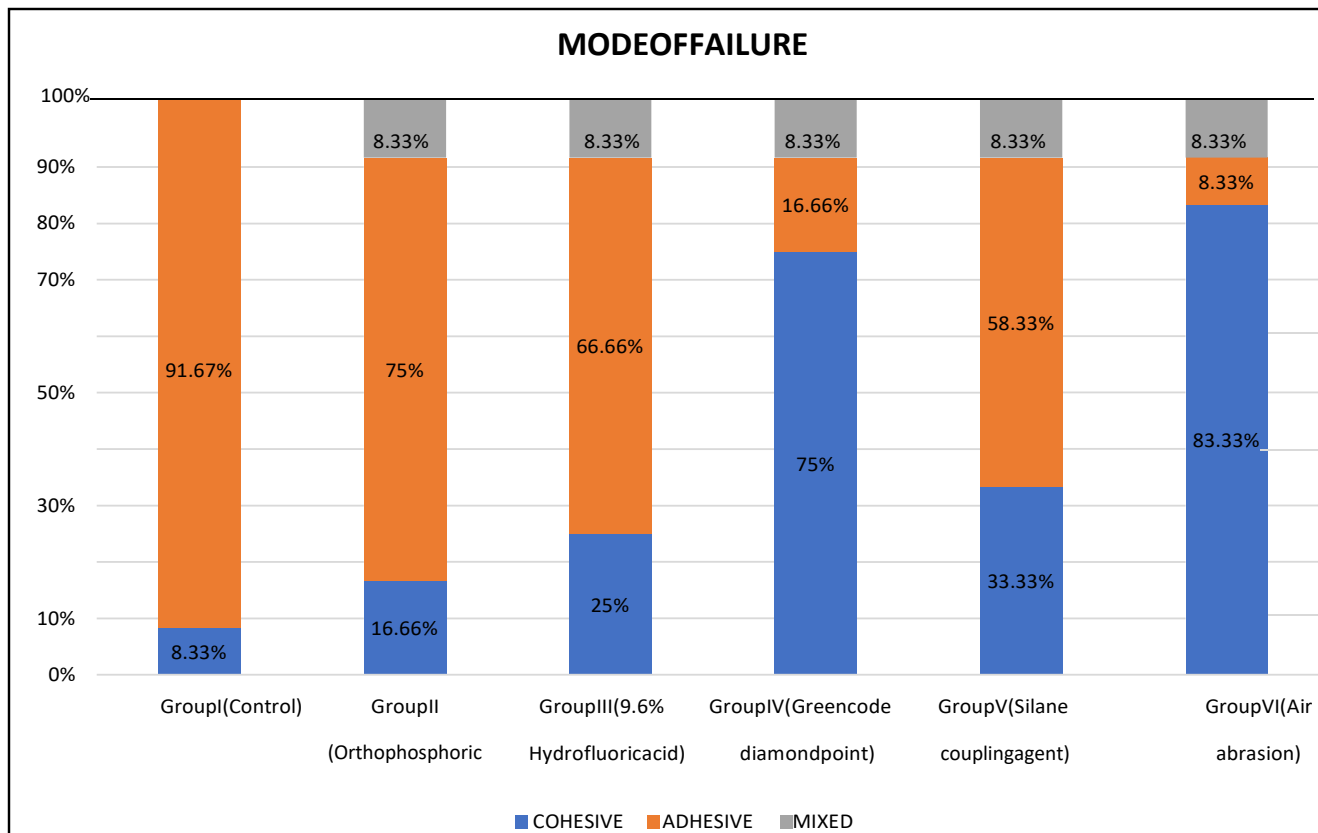
Fig 7 The mode of failure of different groups

The percentage of fracture modes of the samples are illustrated in Table 3. The mode of failure was predominantly in (Gp VI) Air abrasion (83.33%) and Green bur (Gp IV) (75%) groups. Most of the adhesive failure were recorded in control group (Gp I) followed by Orthophosphoric acid (Gp II), Hydrofluoric acid (Gp III), Silane Coupling agent (Gp V).

Fig 7 shows the mode of failure of different groups

In general, failure modes indicate that those groups with high bond strengths exhibited cohesive failure inside the composite. However, low bond strength groups tend to exhibit adhesive failure rather than cohesive failure.²⁹ More cohesive fractures were found in the stronger repair group and most cohesive failures were found in air- abrasion and diamond bur groups, which also had the highest mean repair strength.
