Comparative Analysis of Machine Downtime for Biaxially Oriented Polypropylene Films during Manufacturing

Nishant Tarar¹, Ankit Boora², Bijender³

1. Research Scholar, Department of Printing Technology, GJUS&T, Hisar, Haryana
2. Assistant Professor, Department of Printing Technology, GJUS&T, Hisar, Haryana
3. Assistant Professor, Department of Printing Technology, GJUS&T, Hisar, Haryana

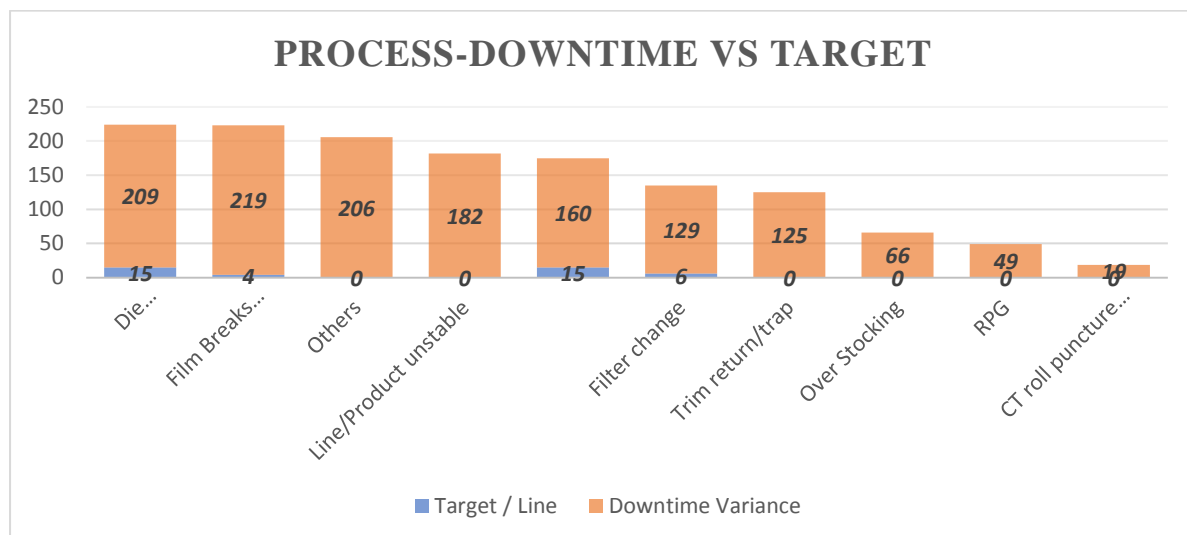
Chart 1.1 Process-downtime vs Preset Target for each downtime

The chart 1.1 basically shows the stacked graph plotted between the **Total-Downtime** in minutes over the Y-axis and various **Sub-factors of Process-downtime** over the X-axis. The

blue part of the bar represents the target which is set by the company. The bar in orange represents the delta or the variance which comes in the downtime value for all these sub-factors. The graph shows that the maximum sub-factor that contributes to the downtime is the Die-lip cleaning whereas the least contributing factor is the CT roll repair. The most deviating sub-factor on the other is Film Breaks with maximum deviation value of 219 minutes than the targeted one.

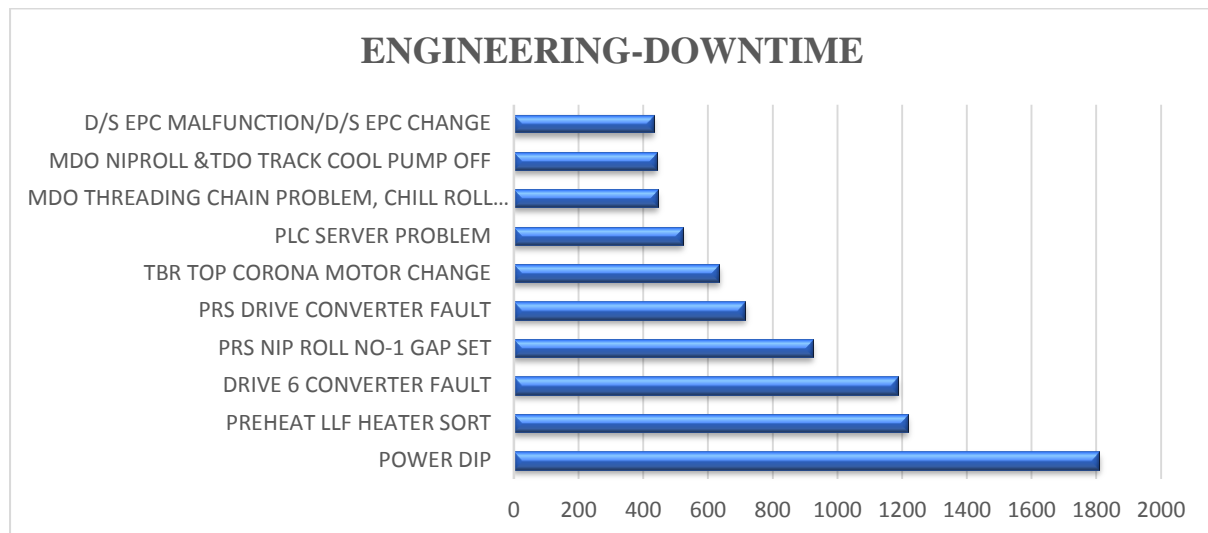
Chart 1.2 Values of Total-downtime for various subfactors of Engineering-downtime

The Chart 1.2 shows the overall comparison between the sub-factors of the **Engineering-downtime** vs the **Total-downtime Value** for each of them. It shows that the maximum downtime caused due to this factor is because of the power-dip or the uneven power supply provided to the machine itself. Whereas the least effecting sub-factor of Engineering-downtime is EPC malfunctioning or its change.

The research shows that the downtime of a BOPP manufacturing machine can be categorized among two different factors which are **Process-downtime** and **Engineering-downtime**. The machine consisted a total of eight Oriented Poly Propylene or lanes based on which the complete data is collected. The result shows that for the Process-downtime the overall value for downtime was 1404 minutes. The downtime taken for each day throughout the research was calculates as minutes per day for which the machine is stopped. The least effecting sub-factor in the Process-downtime was CT roll repair with a value of 19 minutes whereas the most contributing factor is Die-lip and other cleaning with a contributing value of 224 minutes. As for the Engineering-downtime the overall contributing value for it was 8322 minutes. The least contributing sub-factor in it is the EPC Malfunctioning with a value of 431 minutes whereas the most contributing downtime factor for the this and for the overall research was the Power-dip which resulted in a total of 1809 minutes of downtime contributed alone.
